**The Importance of
Manufacturing/Labeling/Shipping &
Installing the correct Material Grade of
Pipe, Valves and Fittings**

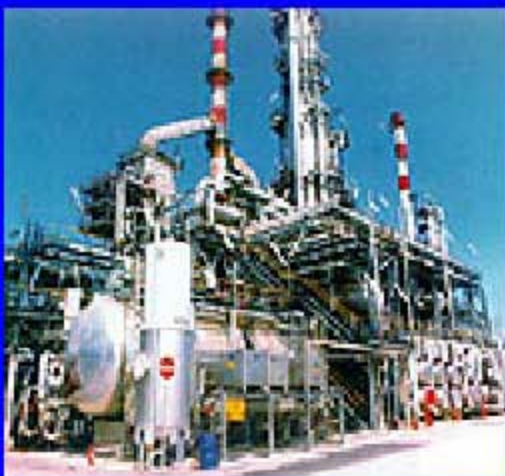
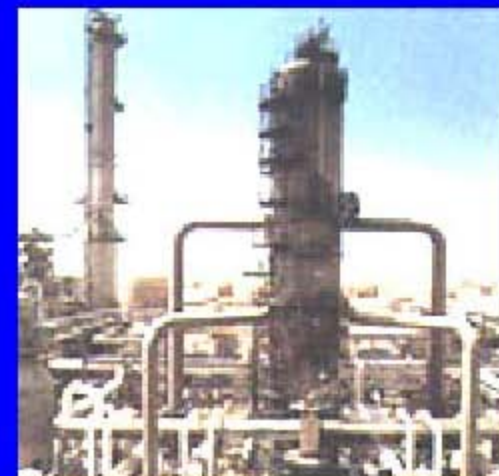
Carbon Steel Valve Substitution (1993)

Accident: Major Line break and Refinery Downtime

Cause: A Carbon Steel Valve painted with Aluminum Paint was installed instead of a Stainless Steel Valve.

Result: The Valve corroded within a few days of use. The valve split, causing a hazardous chemical spill in a processing plant.
