# **Oil Coated Fittings versus Penn Machine Standard Phosphate Coated Fittings**

Humidity & Salt Spray Testing

Purpose: To see poorly coated areas  
that are subject to rusting.

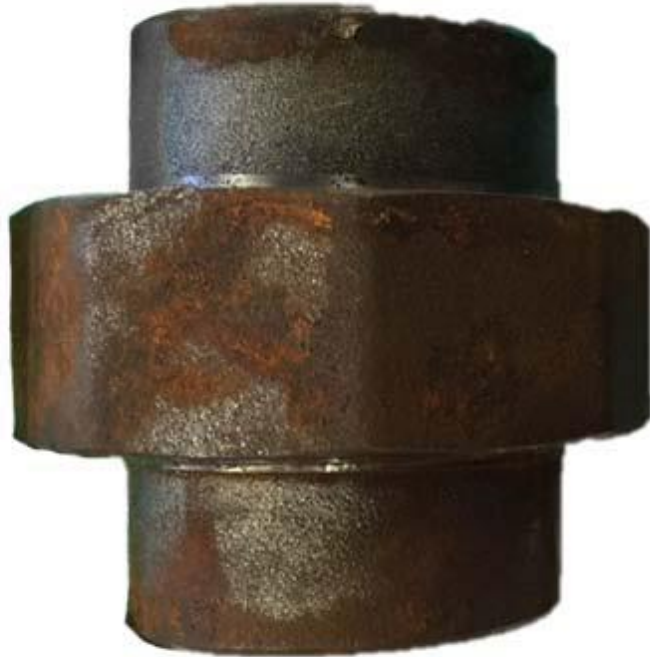
# 24 Hour Salt Spray Test

40% Red Rust  
Observed on  
Oil Coated  
Fitting

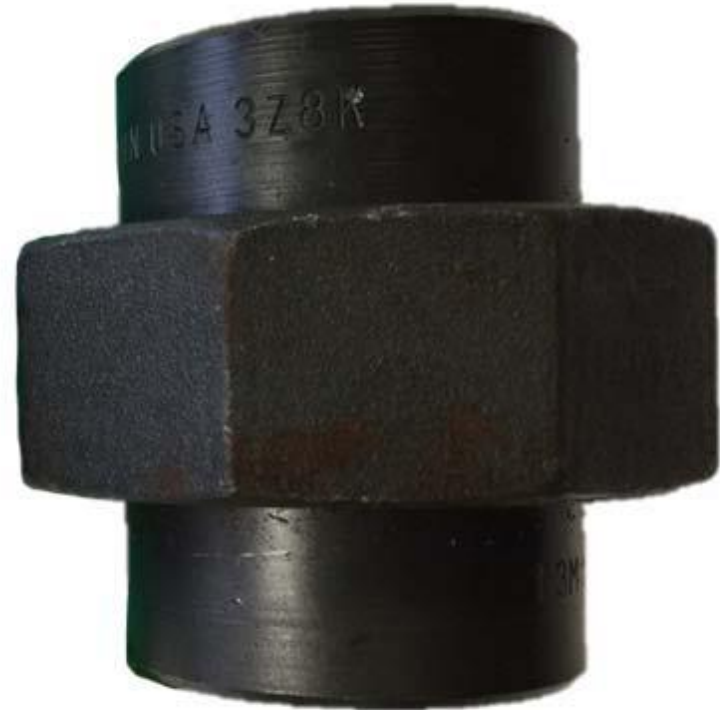
5% Red Rust  
Observed on  
Phosphate  
Coated Fitting

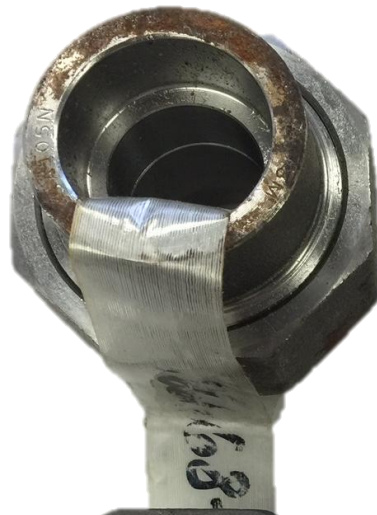
# **336 Hour Non-Condensing Humidity Test**

Heavy Rust  
Observed on  
Faces of Oil  
Coated  
Fittings

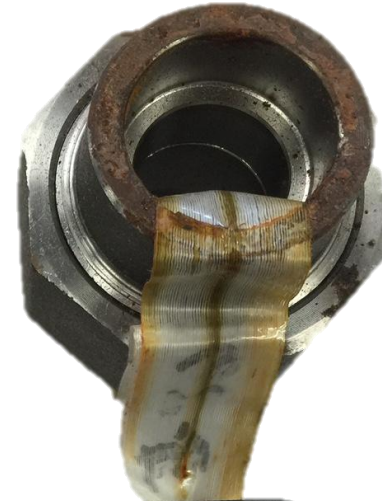
Heavy Rust  
Observed on  
Faces of Oil  
Coated  
Fittings

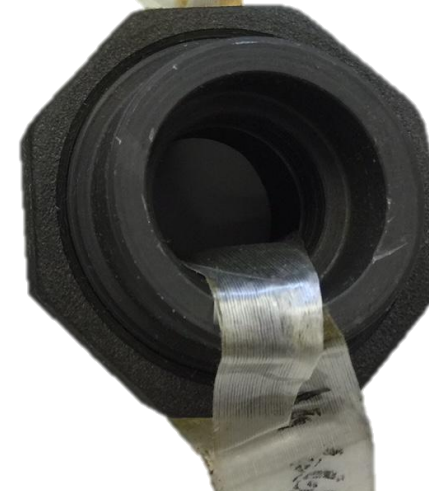
0 – 1%  
Red Rust  
Observed on  
Phosphate  
Coated  
Fittings

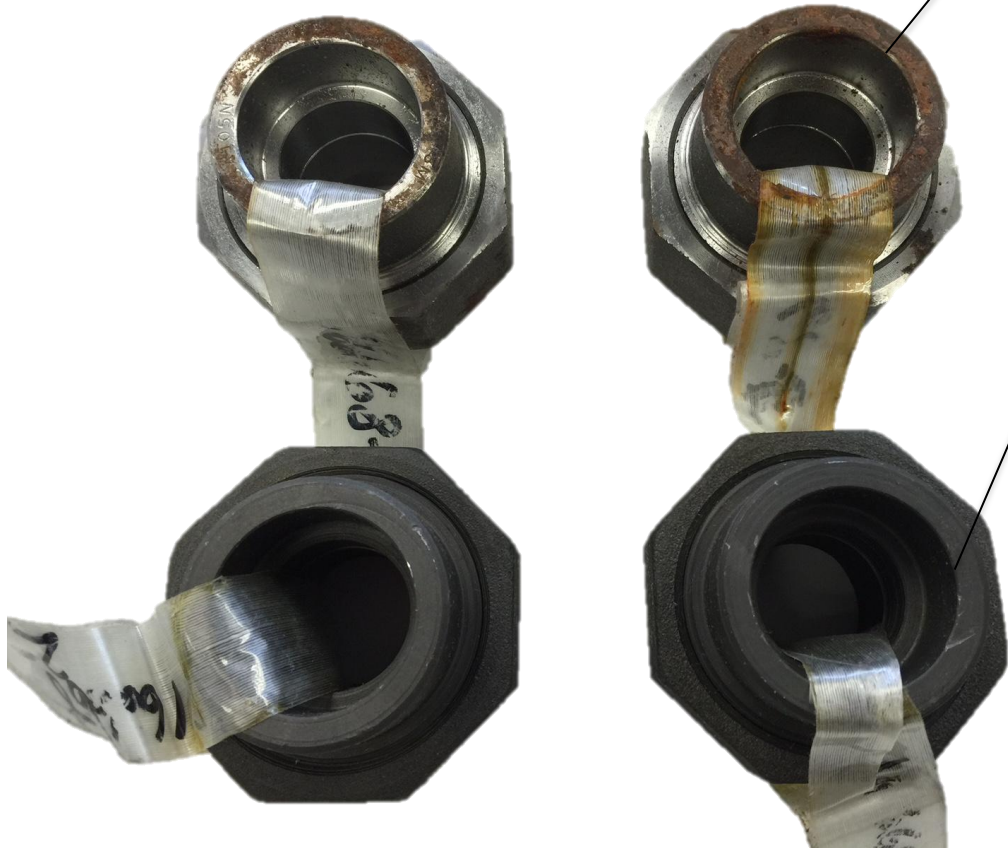
# Oil Coated Vs. Phosphate Coated Fittings

Rust Noticed on Face of fittings as well as other areas of fittings that were Oil Coated, It is evident that the oil is not systematically applied, leaving areas un-protected.

On Phosphate Coated Fitting the coating is uniformly applied. The fittings are evenly coated protecting all surface areas of the fittings.

- Oil Coating does not evenly coat all surfaces of the fitting.
- Oil Coating easily comes off, leaving fitting unprotected.
- Oil Coating application is not uniform and therefore is inconsistent in its application.
- Other Coatings such as phosphate are uniformly applied to all surfaces both internal and external.
- Testing and Pictures show the inadequate protection of all surfaces of sampled fittings using Oil Coating versus Phosphate Coating.
